### Noise Report from 24 September'18 to 29 September'18 (ie 5.5 days)

Readings from 24-09-2018 08:00 for 5 days

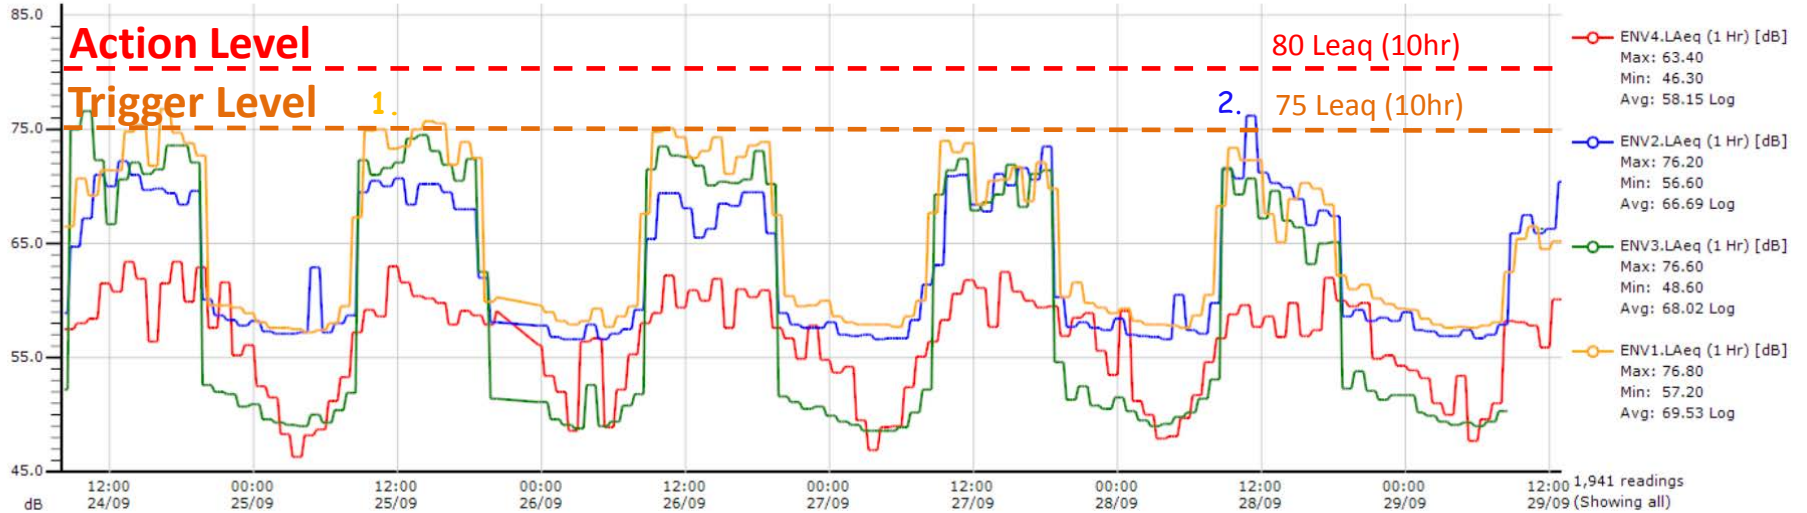
#### High reading explanations :

1. Breaking up of ground slab/buried obstructions with concrete breaker adjacent to EnviroGuard 1.
2. Piling rig working immediately adjacent to EnviroGuard 2.
